Dam Before Construction

**Warner's Dam Before Rehabilitation
Summer 2007**

November 2005 Dam Safety Inspection

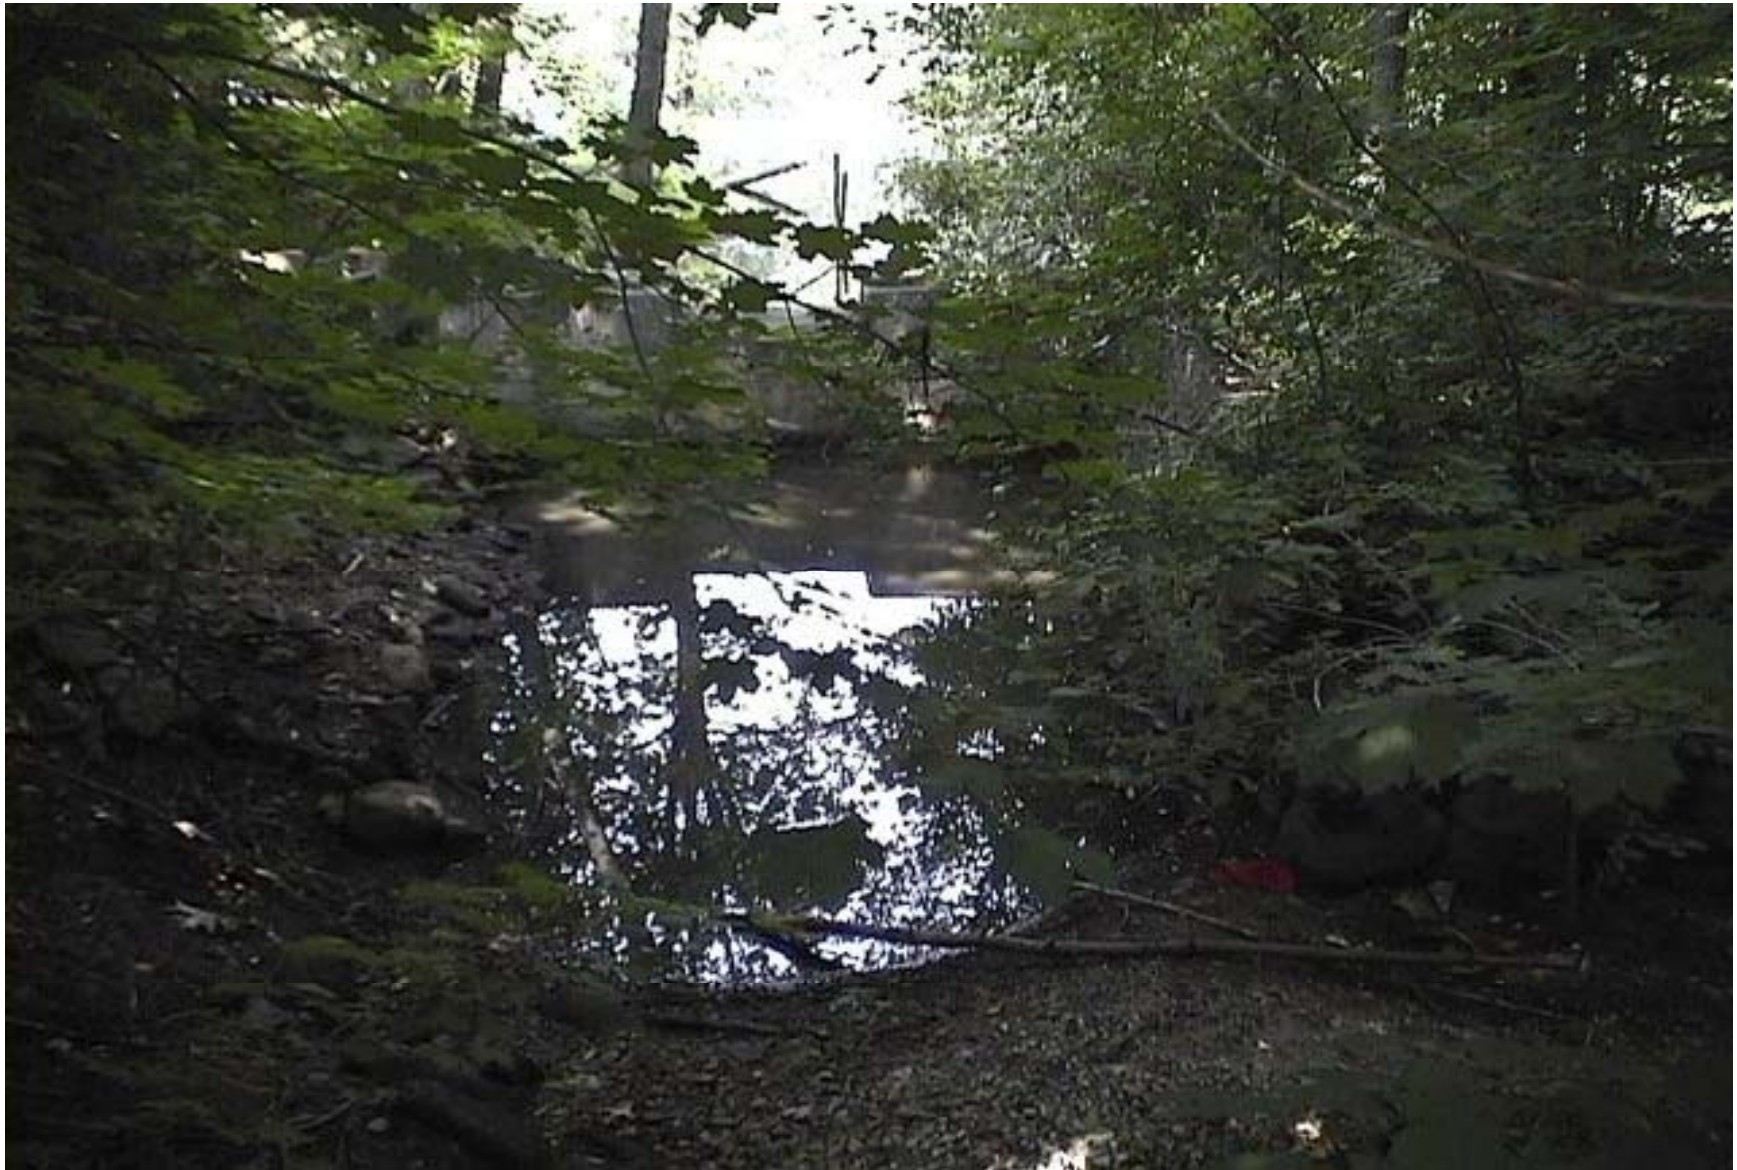
**View onto Small Spillway from
Commonwealth Avenue – Summer 2007**

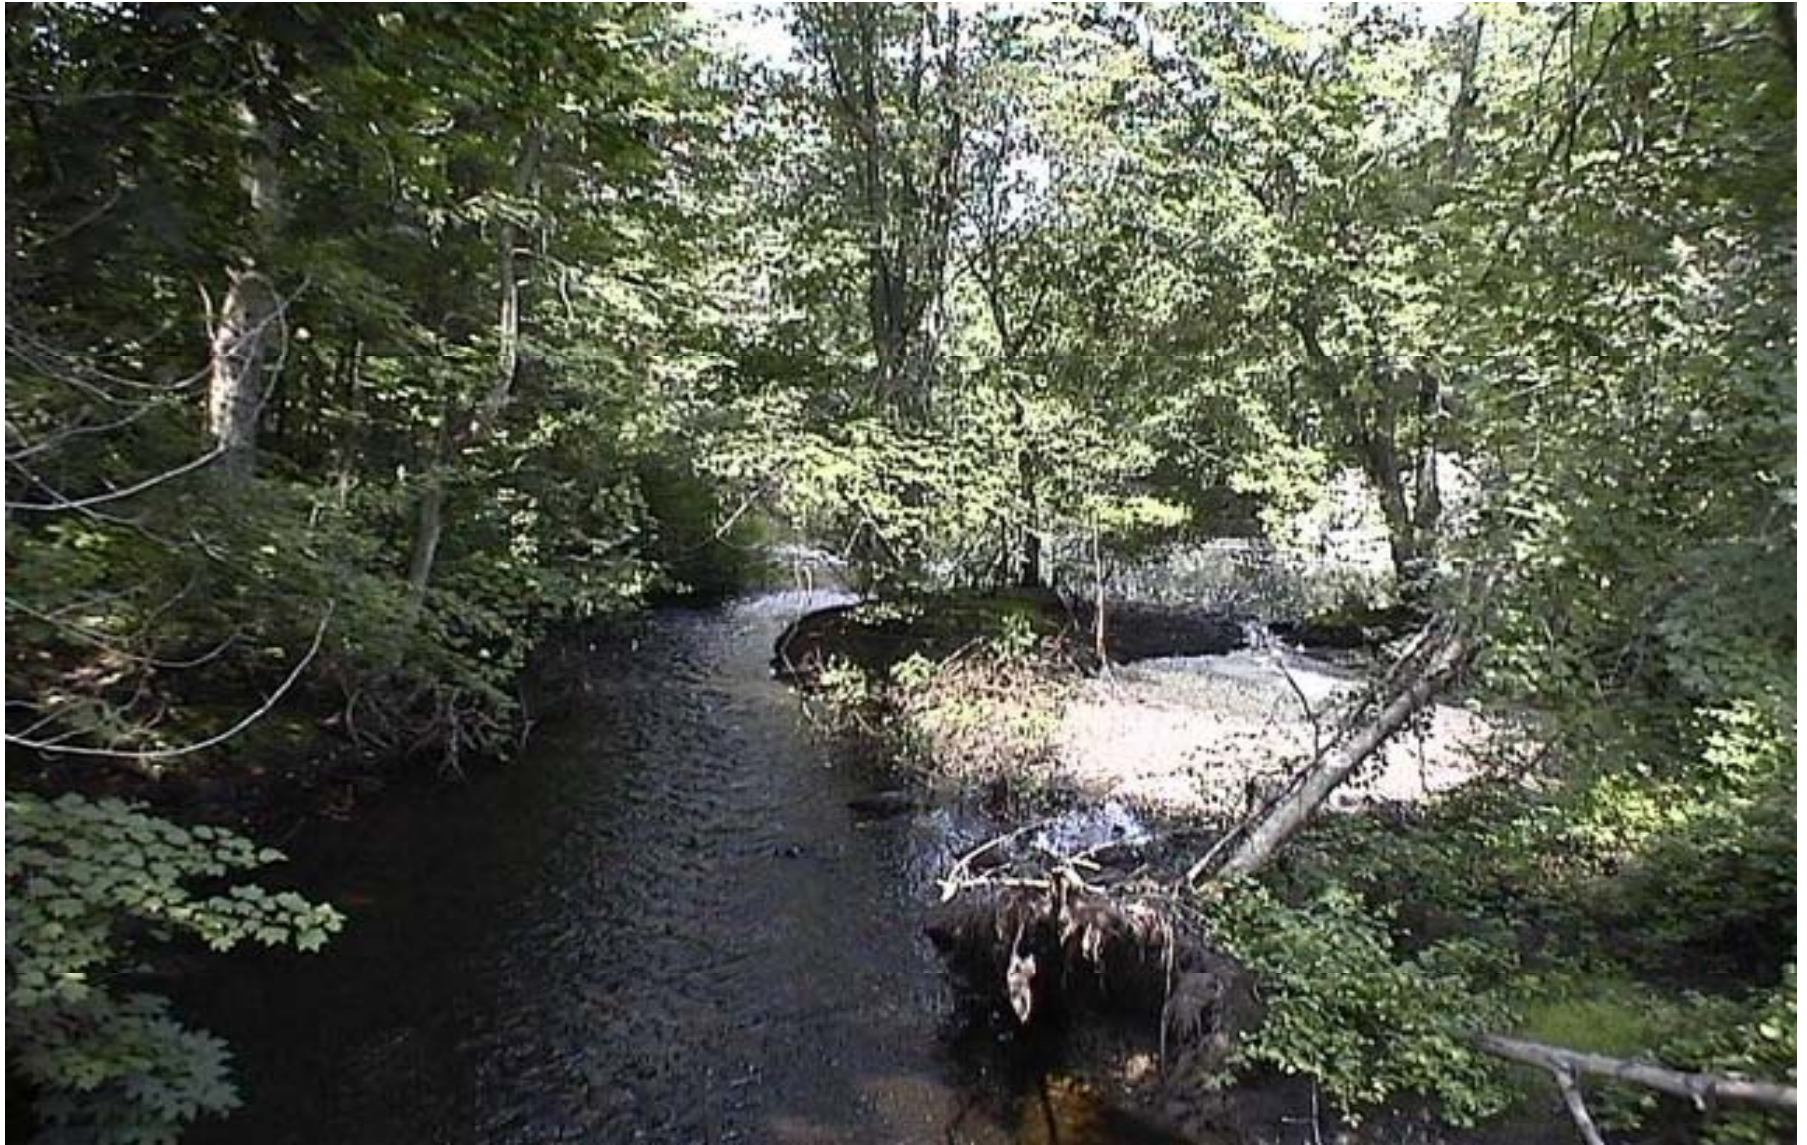
**Main Stream from Dam Looking Towards
Commonwealth Avenue - Summer 2007**

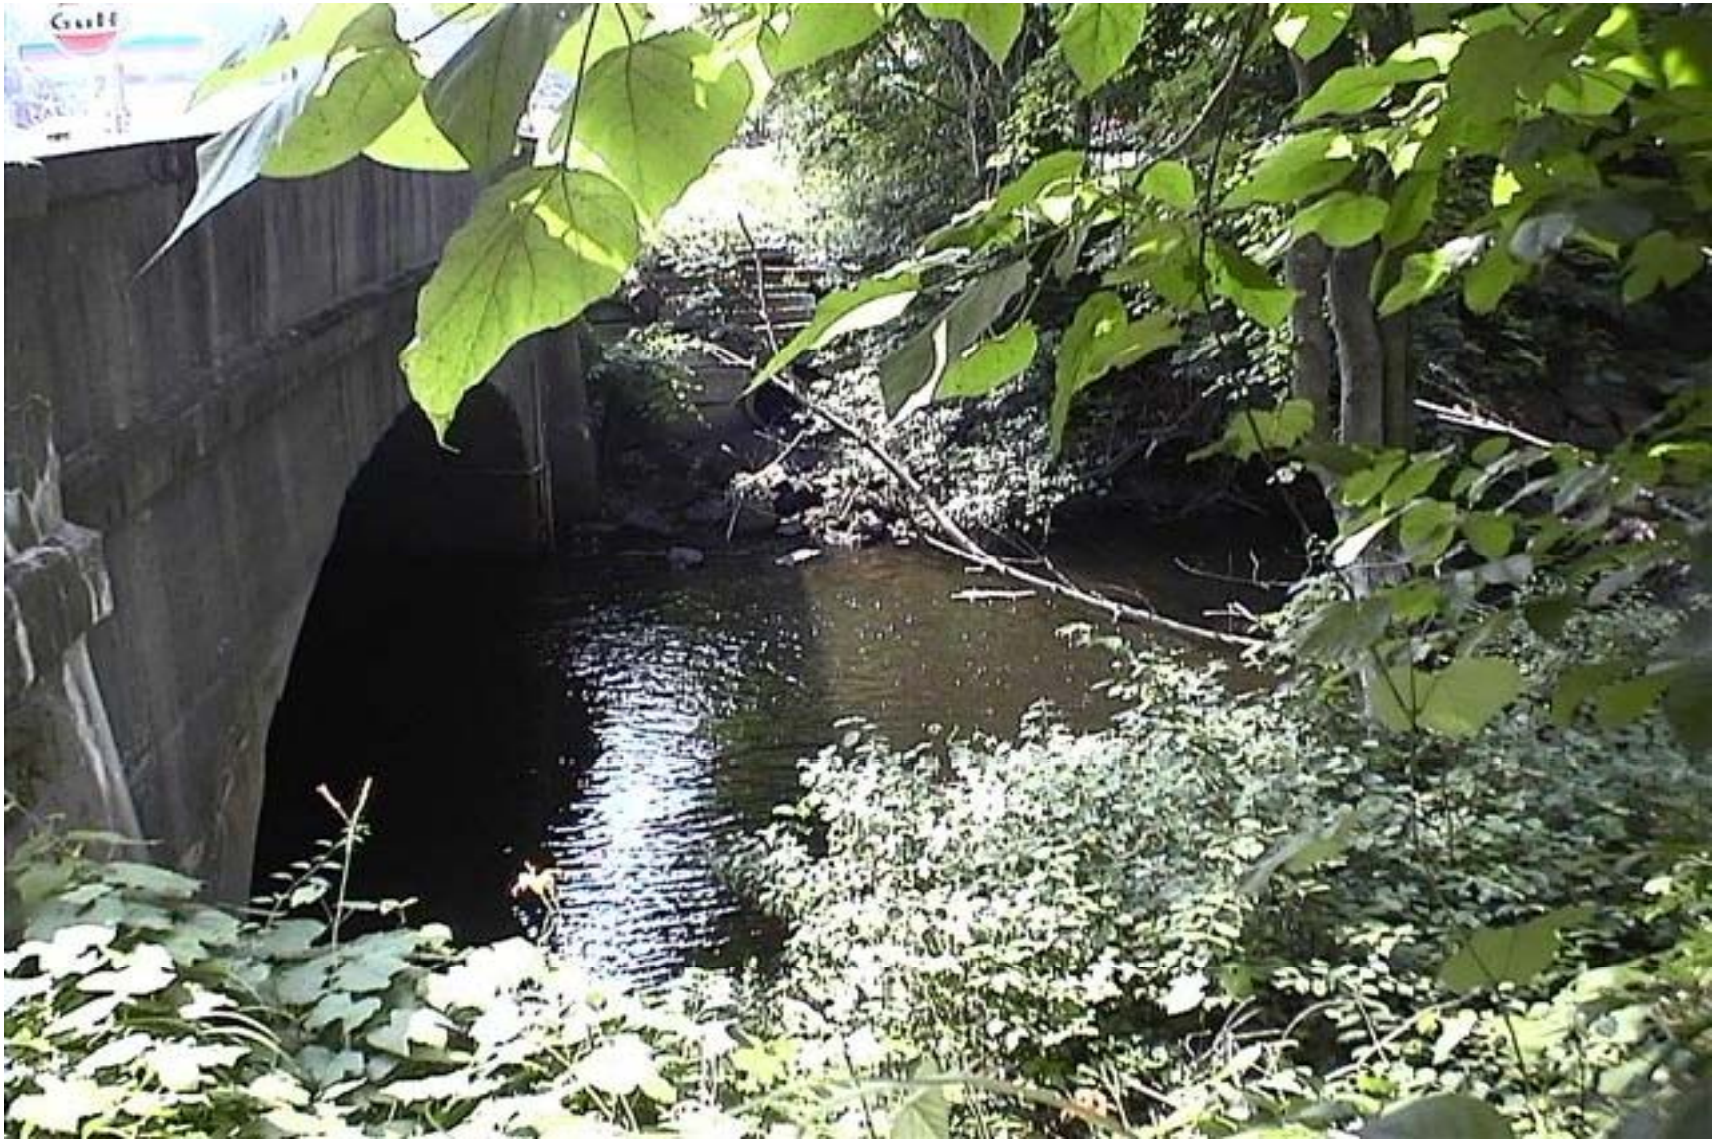
**Pail Factory Bridge on the Dam Side
Summer 2007**

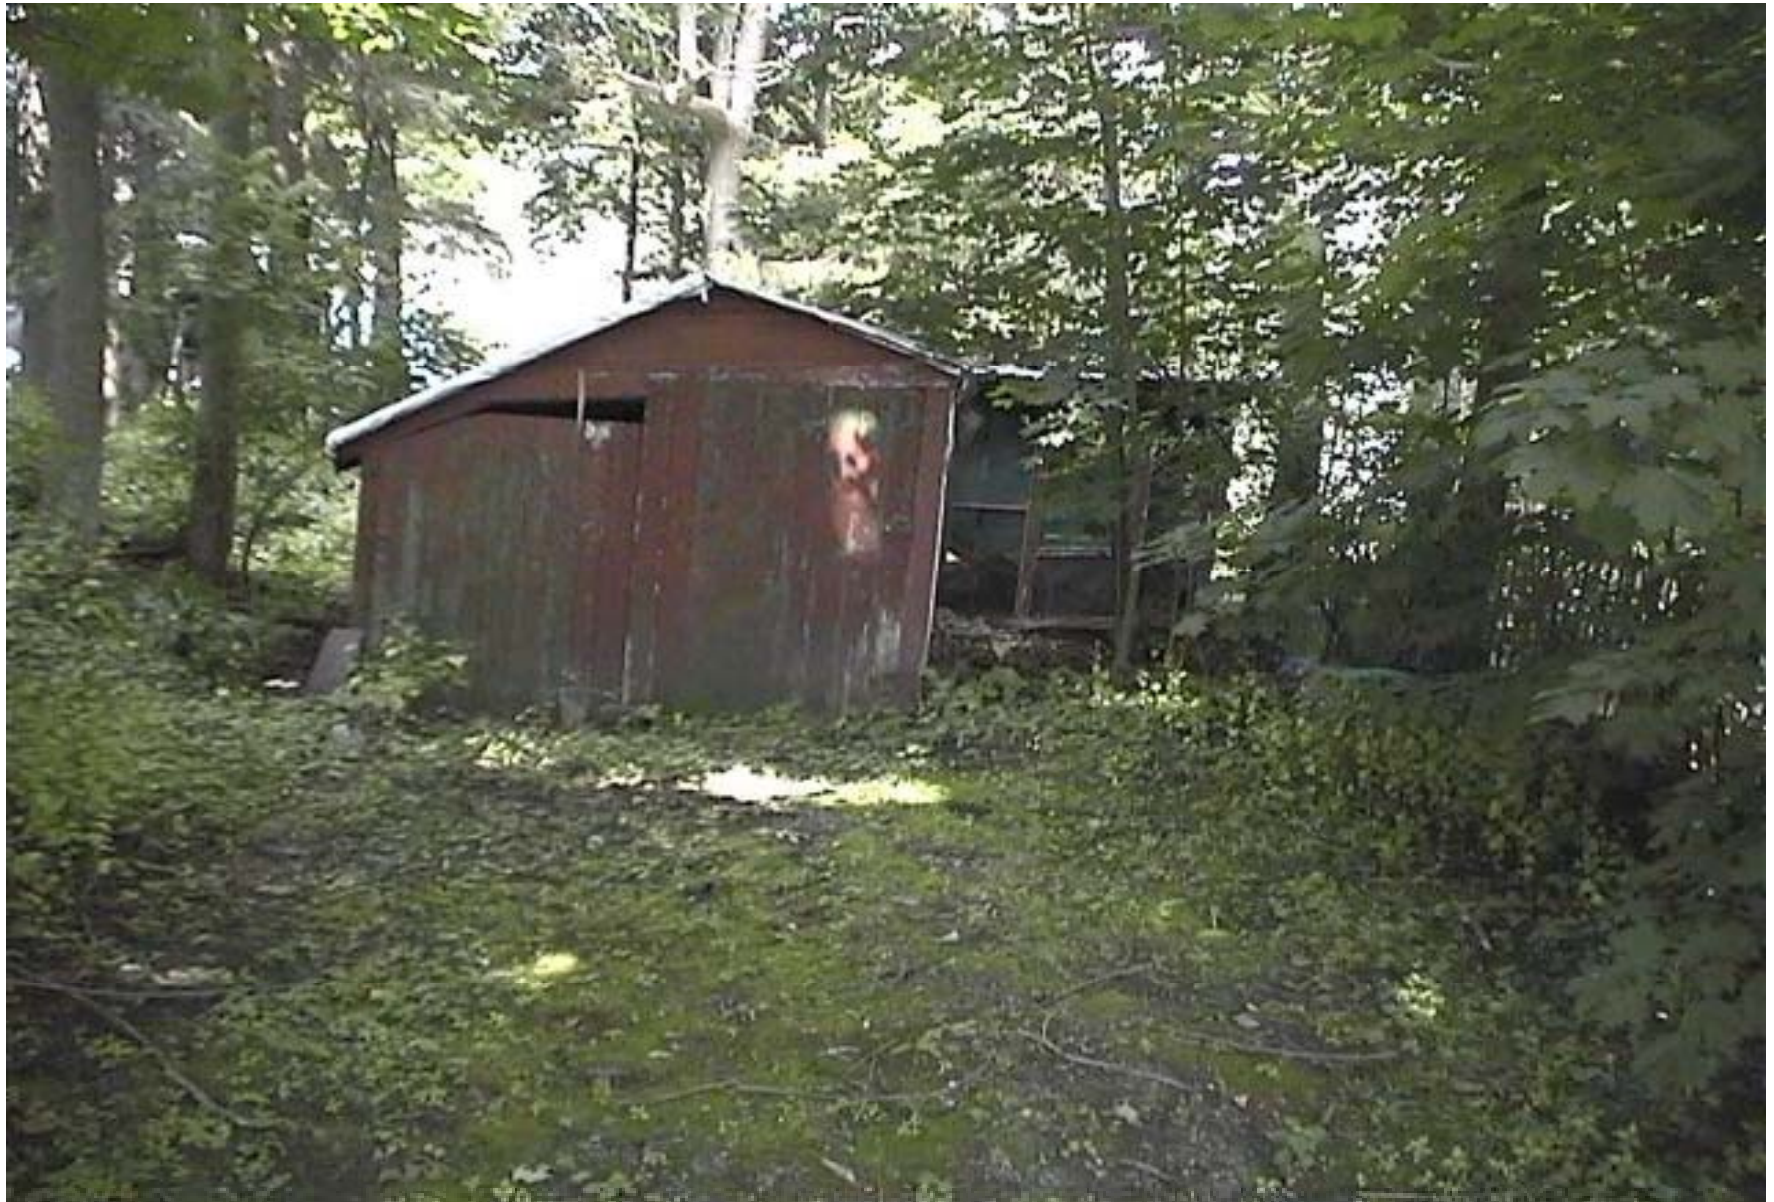
Future Pocket Park Left of Bridge

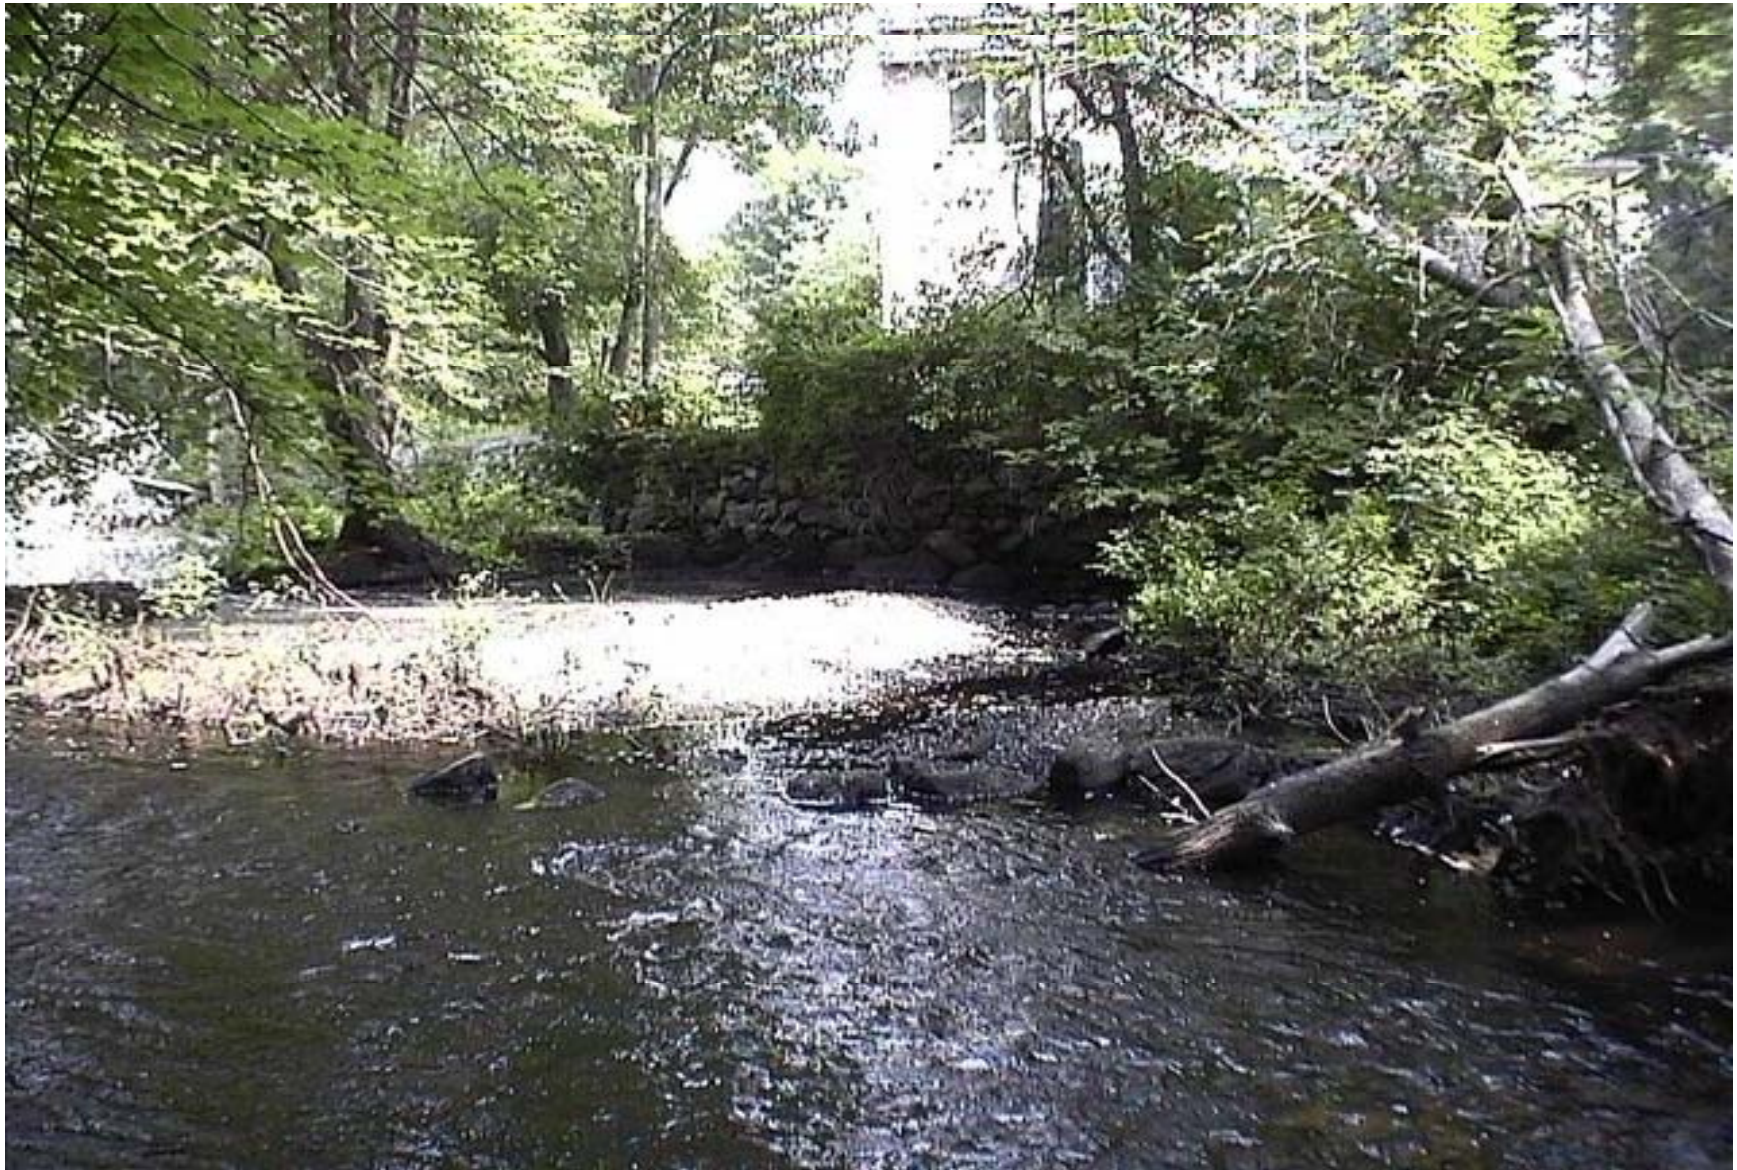
**Stone Wall Bordering the Denaro Home
Summer 2007**

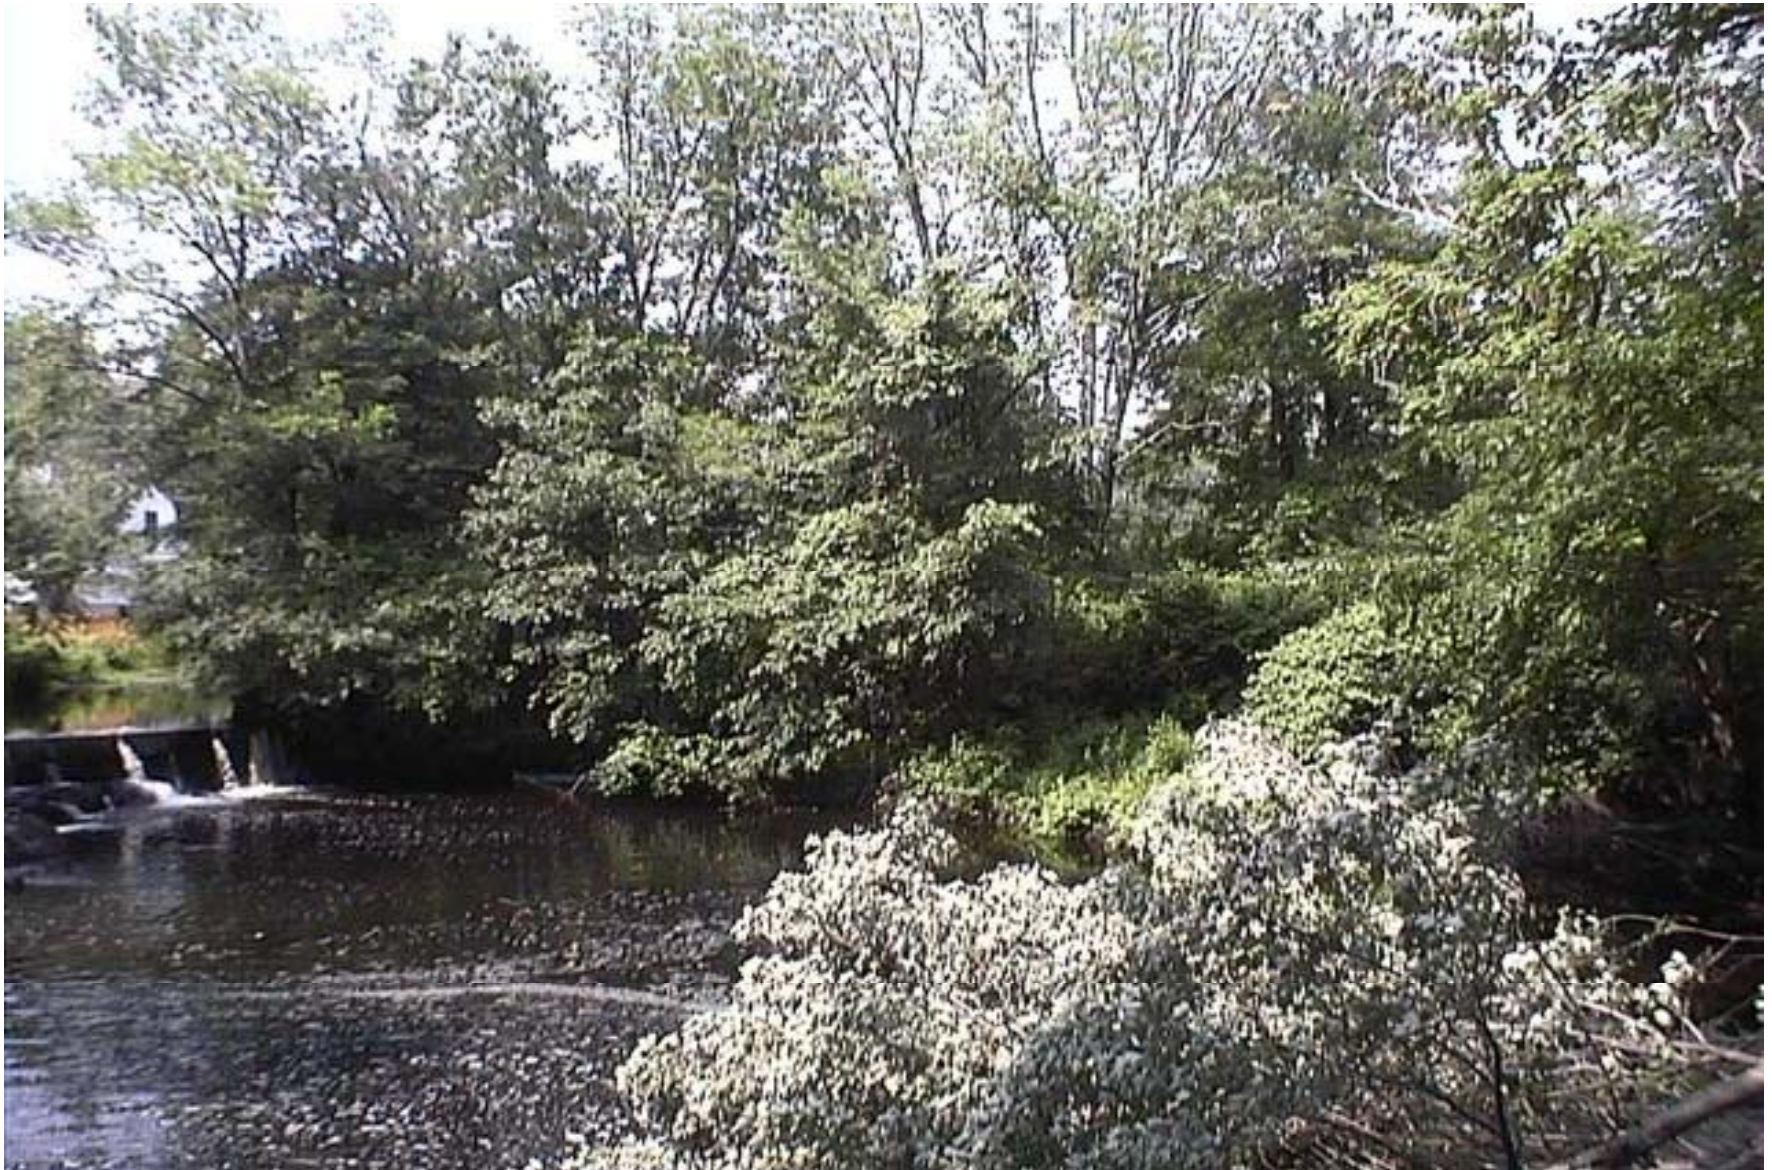
**Earthen Dam Before Tree Removal
Summer 2007**

- Failure of right (east) spillway training wall.
- Severely eroded earth embankment with signs of previous overtopping.
- Inoperable outlet controls.
- Lack of emergency site access.
- Heavy tree and brush growth on earth embankments.
