**WARNER'S POND MANAGEMENT PLAN
CONCORD, MASSACHUSETTS**

September 1999

Town of Concord
Division of Natural Resources
141 Keyes Road
Concord, MA 01742

Aquatic Control Technology, Inc.
11 John Road
Sutton, MA 01590-2509

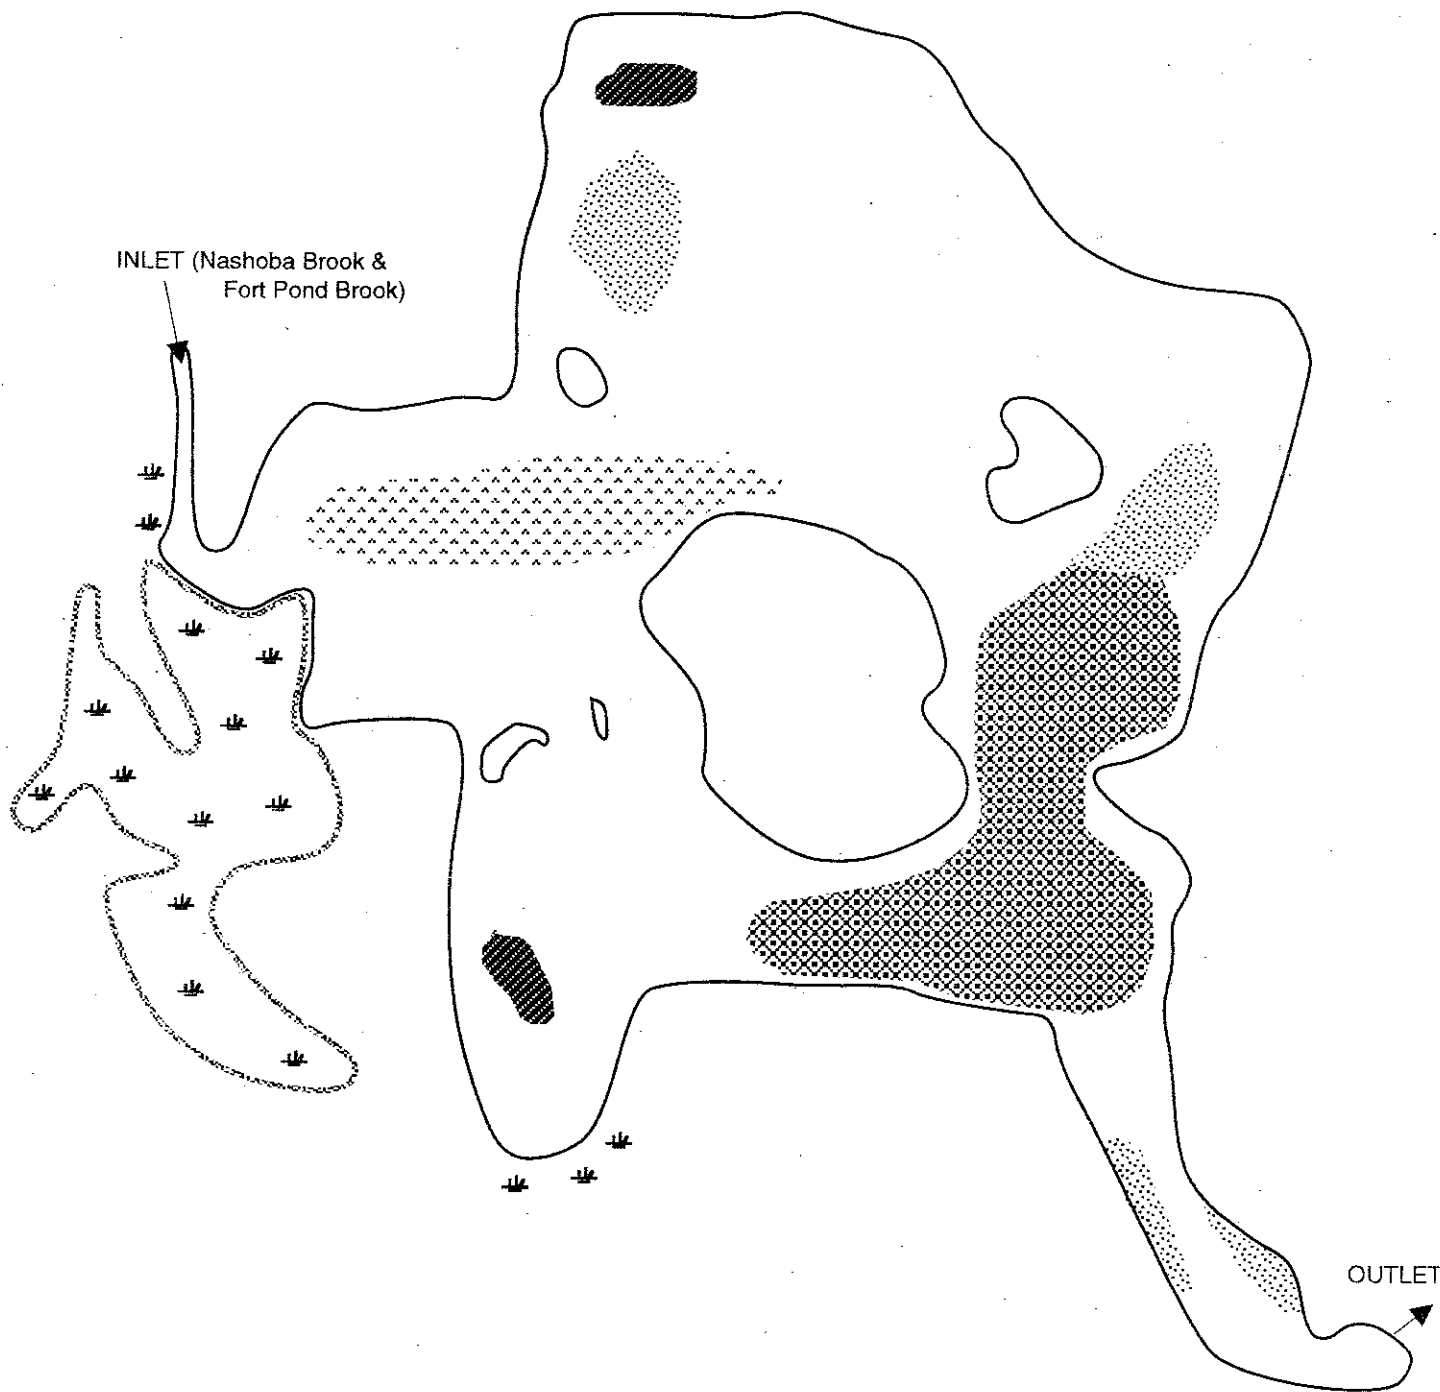
The non-native or exotic plant cover in Warner's Pond was mapped separately in Figure 6. The three non-native aquatic plants identified are fanwort, water chestnut and variable watermilfoil. Purple loosestrife, a non-native emergent/wetland plant is also widely scattered around the entire pond shoreline, and is well integrated into the dense stands of water willow found on the western side of the pond.

Fanwort was clearly the most widespread non-native plant, but never was it the most abundant plant in a given area. The greatest concentration of fanwort was found in the southeastern corner of the pond. Variable watermilfoil appeared to be limited to a narrow band extending from the Nashoba Brook inlet to the northern side of Boy Scout Island. Coontail appeared to be equally abundant in this area. The non-native plant that probably presents the greatest threat to further reducing open-water conditions in Warner's Pond is water chestnut. Only a few isolated patches of water chestnut growth were found interspersed in the dense waterlily cover at the northwestern and southwestern ends of the pond. The water chestnut coverage appears to have been kept at manageable levels through Town sponsored hand-pulling efforts over the past several years.

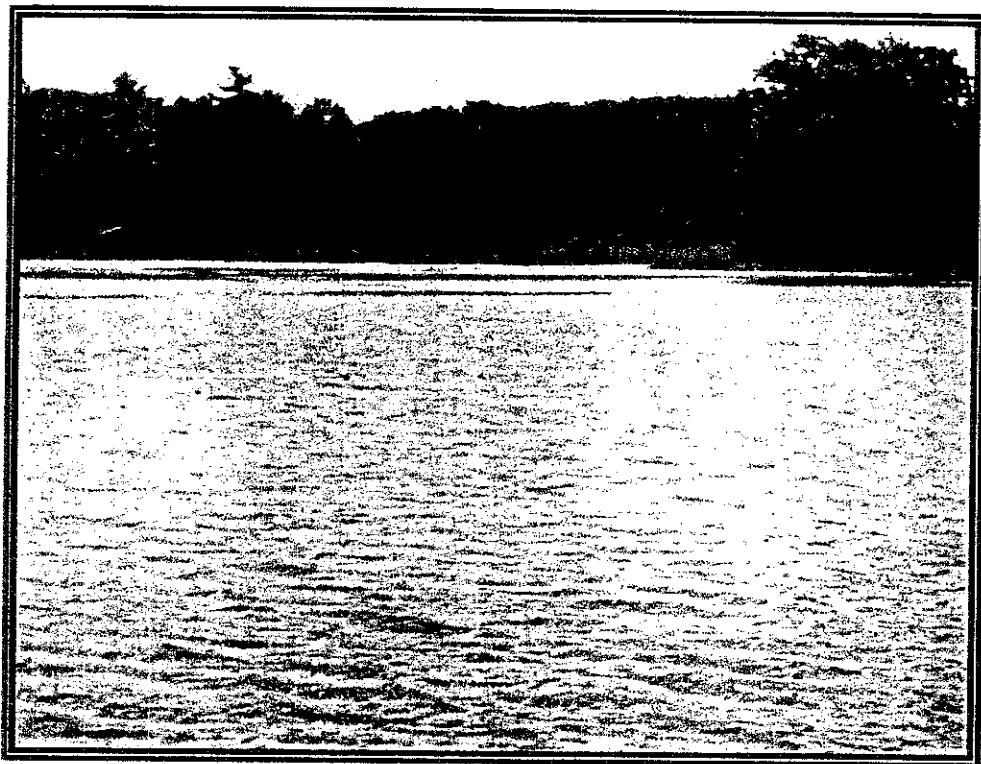
*Open Water outlet channel with silty water
and typical channel shore line*

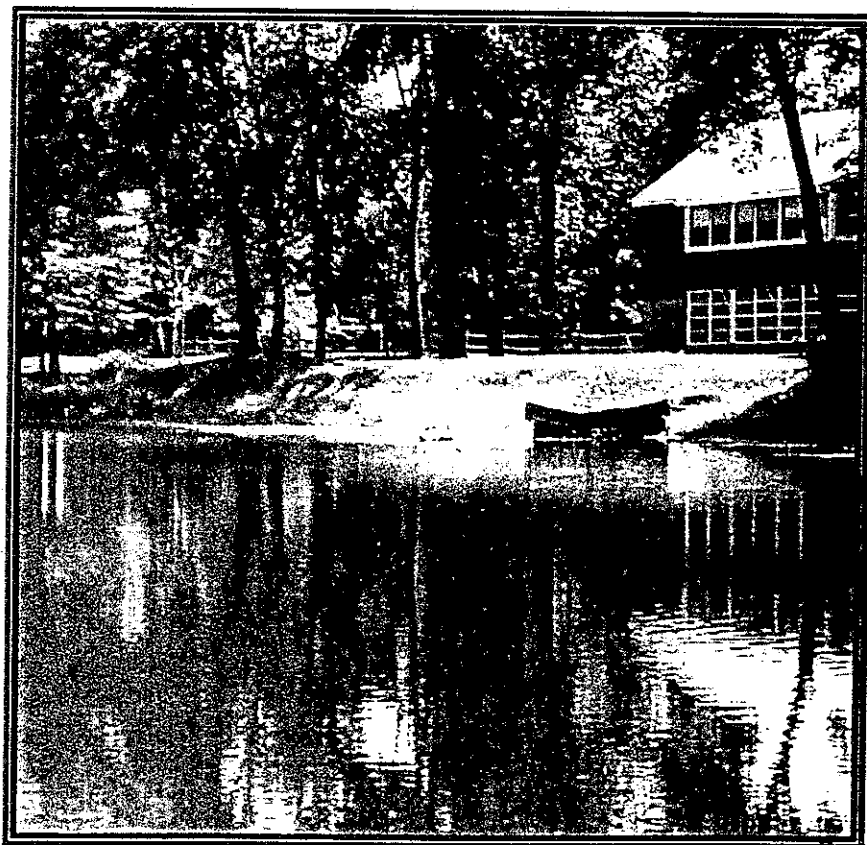
*Northeast area of Warner Pond with
open water habitat*
